## **Water Entry through Roof Sheathing Joints and Attic Vents: A Preliminary Study**

### **Sealed Roof Deck Tests**

Demonstrating the value of sealing the roof deck and providing information on the relative importance of water entry through vents compared to the roof.

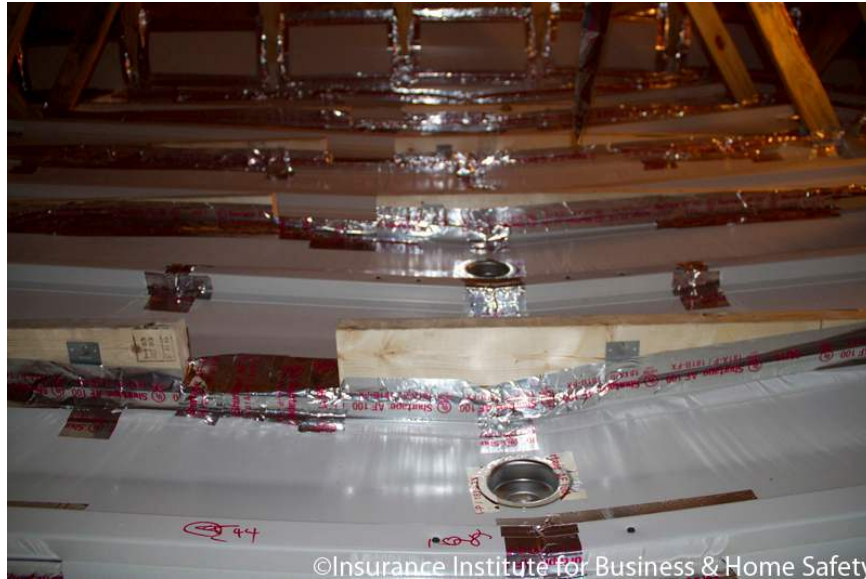
**Figure 1. Photograph of water collection channels between ceiling trusses in duplex.**

Drainage panels and tracks (DrySpace™) were installed in the attic to create water collection channels between the ceiling trusses, as shown in Figure 1. These channels were outfitted with drains and pipes that allowed collected water to be captured in plastic containers arranged throughout the interior (non-attic) space in the two halves of the duplex. The drainage system was installed so that the collected water could be segregated by zones. These zones were roughly 3 m (10 ft) long by 0.6 m (2 ft) wide. The trusses ran from the front to back of the house. The between truss spacing was divided into three sections, each about 3 m (10 ft) long. Each drainage channel directed water to a separate numbered plastic container. Typical drain and collection locations are shown in Figure 2. Tests were typically conducted for a 1200 s (20-min) period, during which time a constant wind speed was maintained. The rainfall rate was set to produce 730 m/s (8 in/hr) on the test building (i.e., horizontally-driven rain). At the completion of each test, water in the buckets was measured and recorded.

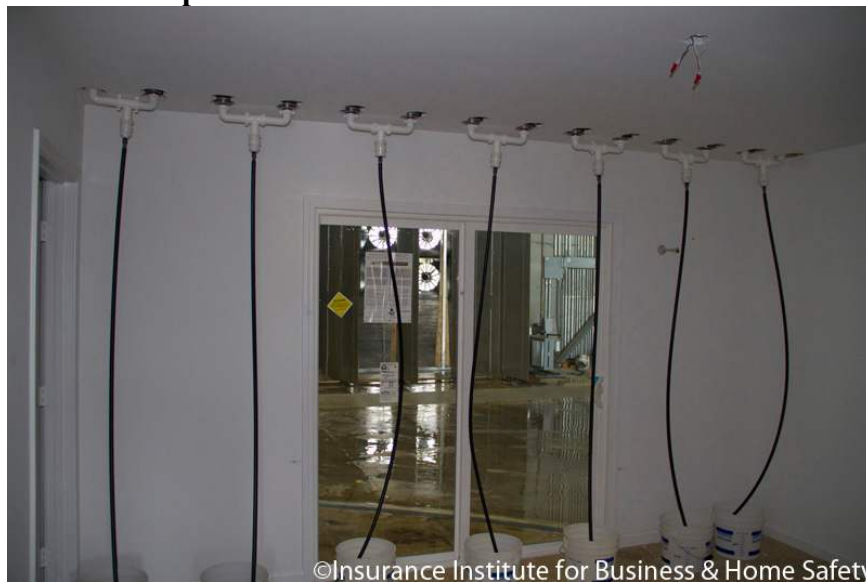
**Figure 2. Photograph of water collection system inside the duplex.**

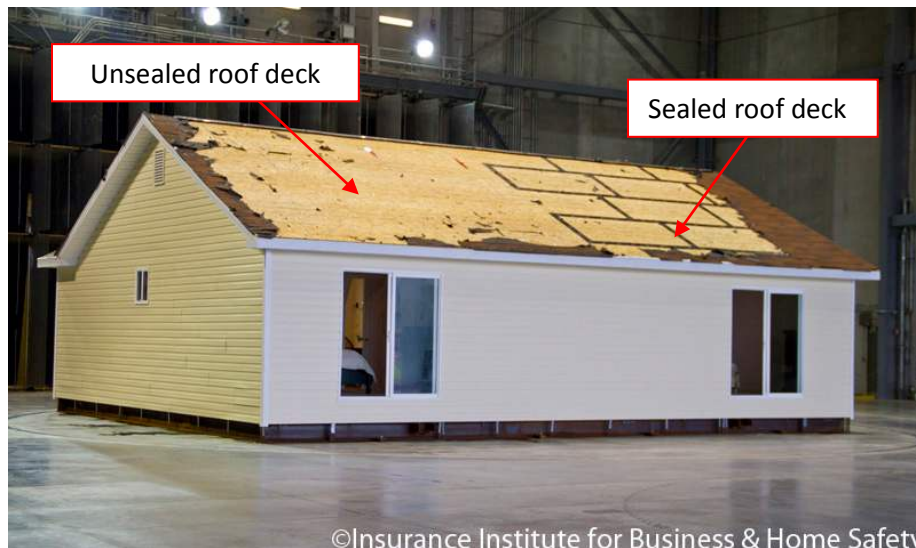
**Figure 3.** Photograph of the back of the duplex after shingle and underlayment (manual) removal, illustrating the sealed roof deck (right) and the unsealed roof deck (left).

The final test evaluated water entry through the sealed and unsealed sheathing joints. The wind speed for this test was 22.4 m/s (50 mph), with the back (eave side) of the duplex facing the wind flow. This configuration put the exposed sealed and unsealed roof decks, shown in Figure 3, perpendicular to the wind-driven rain to allow a relative comparison in the amount of water entry in the attic for each half of the roof.

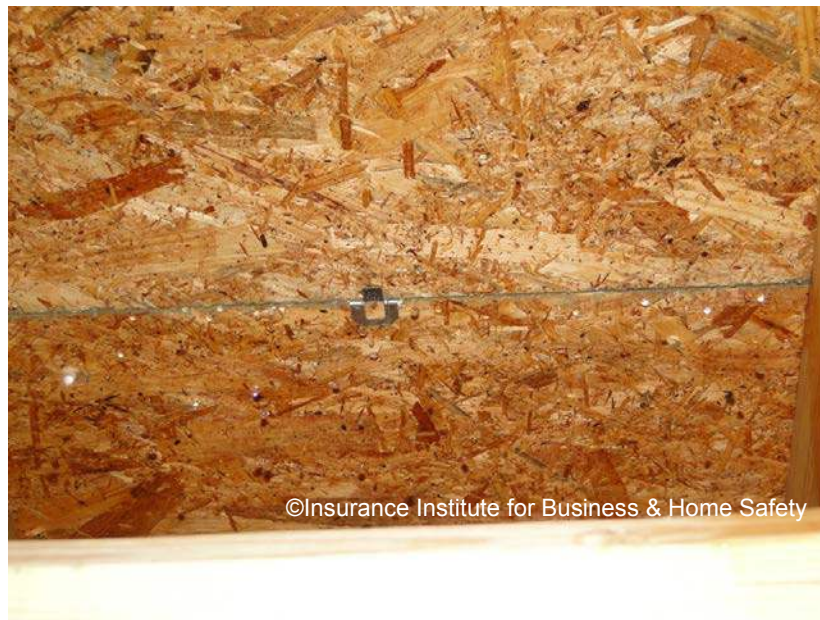
**Figure 5.** Small tears in the tape occurred when a roofing shovel was used to remove the roof shingles. Water droplets can be seen falling from the between-sheathing joint gap shown in this photograph.

Water entry through nine nail holes and one damaged taped sheathing joint was measured during one test conducted at 31.3 m/s (70 mph). The water collection time at each nail hole was not uniform and in each case was less than that at the joint. The nail holes that would leak were not known until the start of the test. Once water was observed dripping from a given nail hole, water collection began. Water accumulation at one damaged joint was measured during the 20 minute exposure time. The results of this test indicated that water entry through the damaged joint was approximately three times that through a given nail hole. Because average measured accumulation times at a given nail hole was less than that at the taped joint, water entry at the joints would have been greater than the value reported here.

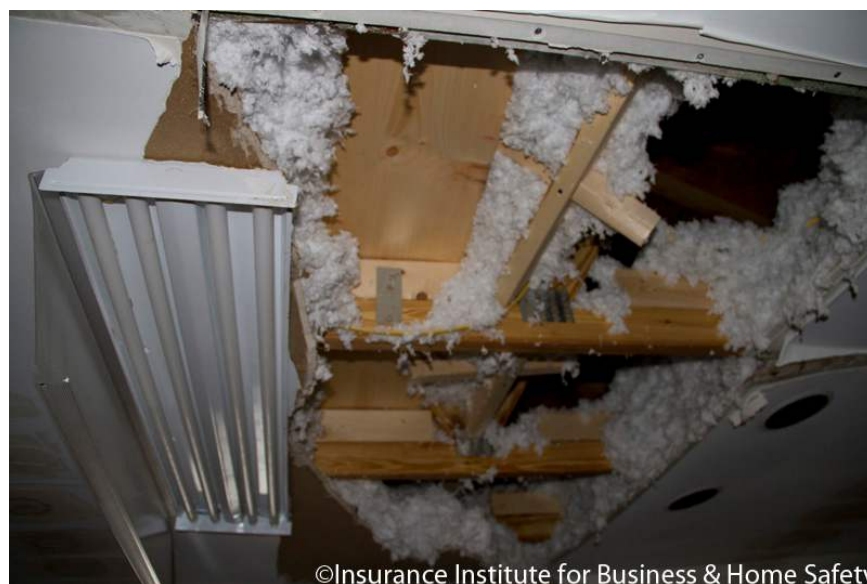
**Figure 6.** Photograph of collapsed ceiling in the kitchen on the unsealed roof deck side of the duplex.

Following quantitative testing, the water collection devices were removed from the structure and the required drainage holes in the ceiling were patched. Furniture was placed in the duplex to model actual living spaces. The finished structure was then subjected to a series of wind-driven rain events modeled after Hurricane Dolly. These tests gave IBHS the opportunity to demonstrate the consequences of water entry into attic spaces. Within 45 minutes of the conclusion of the 20-minute wind-driven rain exposure, the kitchen ceiling in the unsealed side of the duplex collapsed (Figure 6).
